November 2009

WearSox Silver Corrosion Testing Summary

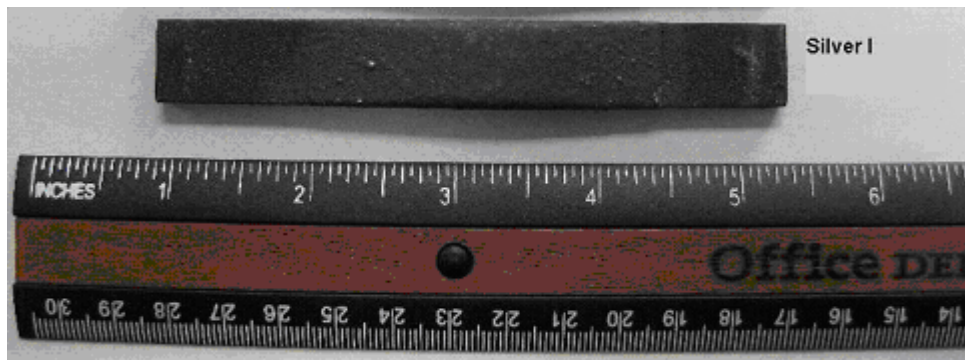
An autoclave SCC test (NACE TM0177-96 Method "B" as modified by ASTM G39-05) was conducted in order to determine the susceptibility of the coating (~15% alloy content) to stress-corrosion cracking. Below (Figure 1) is an image of the sample after testing. The test was conducted at 80% stress level at 1,000 psi (50 psi H₂S, 400 psi CO₂, balance N₂) in a 5% NaCl solution and at a temperature of 350°F for a period of 7 days.

Figure 1. Thermal spray coating after autoclave SCC test

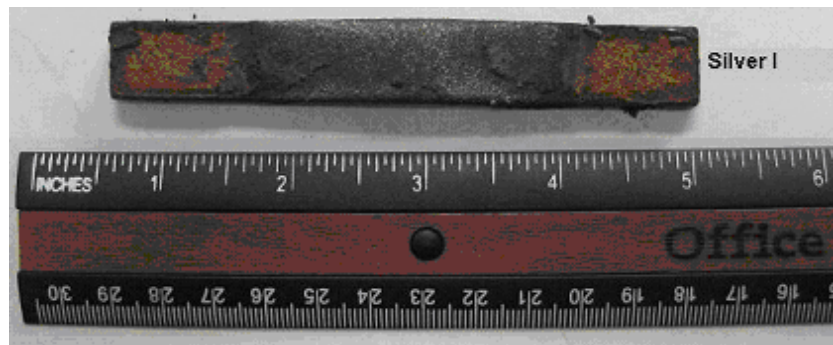
A salt spray corrosion test (ASTM B117-09) was conducted on WearSox Silver in order to determine its susceptibility to salt water corrosion. The specimen was tested for a total of 312 hours. SEM analysis was conducted and only general corrosion was observed with no evidence of pitting or intergranular corrosion (Figures 3,4).

Figure 3. Thermal spray coatings after 312-hour salt spray (fog) test

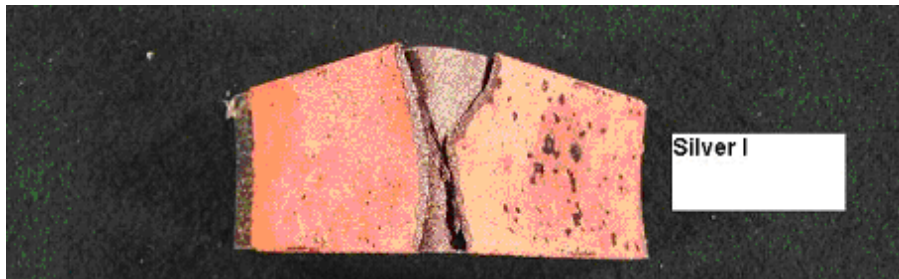
An intergranular corrosion test (ASTM A262-02a Practice E) was conducted on WearSox Silver. The coating was deposited on a 625 nickel-based alloy. The coating failed upon 180° bending, which was expected (Figure 5).

Figure 5. Photograph of the sample after bending 180°

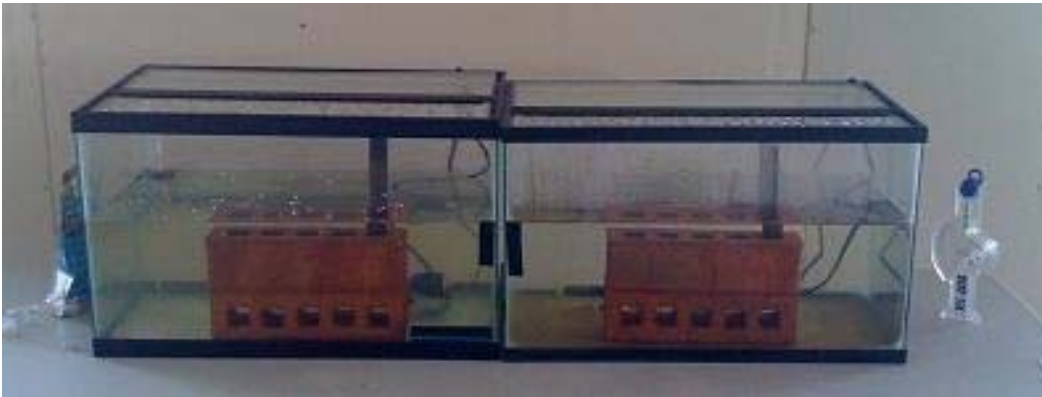
A custom salt fog test was developed and conducted at Devasco International, Inc. WearSox Silver samples were placed partially submerged in salt water in order to observe the effect of the environment above, below, and at the water line (Figure 12). A 304 stainless steel rod was placed in each tank as a control. Two types of water were used during testing: a synthetic sea salt mixed with deionized water and salt-water taken from Galveston Bay. The water temperature of the tanks was held at approximately 34°C and the specific gravity was monitored and held at approximately 1.02. Samples were tested for a total of 25 days.

Figure 12. Photograph of custom-designed salt fog experimental arrangement

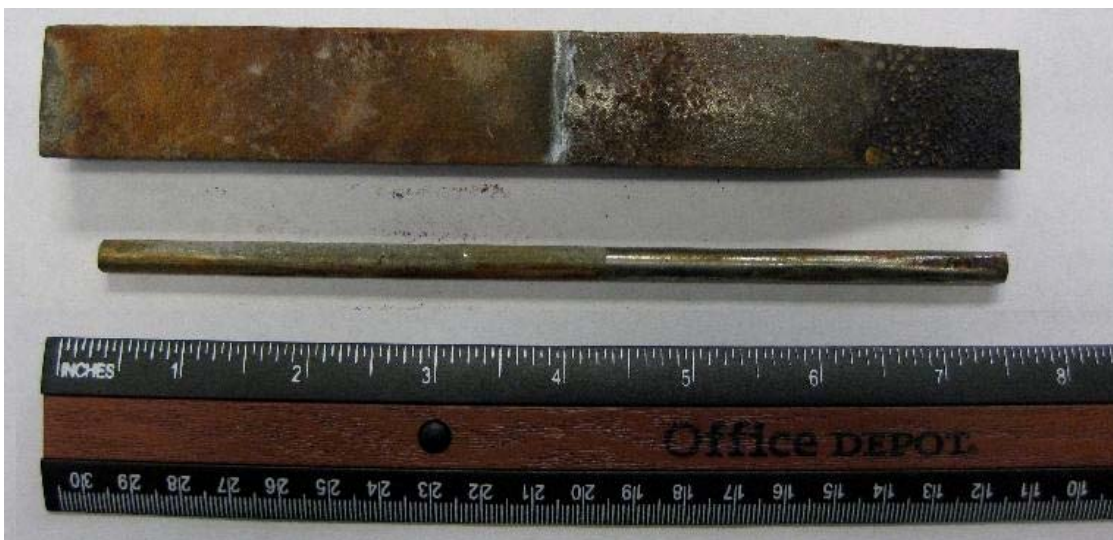
Figure 13. Synthetic seawater sample after 25 days in custom salt-spray test

Only general corrosion was observed on the samples tested in synthetic seawater (Figures 13, 14) and natural seawater (Figures 15, 16). On both samples, regardless of environment, the predominant constituents of the surface scale were chlorine, oxygen, calcium and iron. These are indicative of deposited salts and corrosion products.

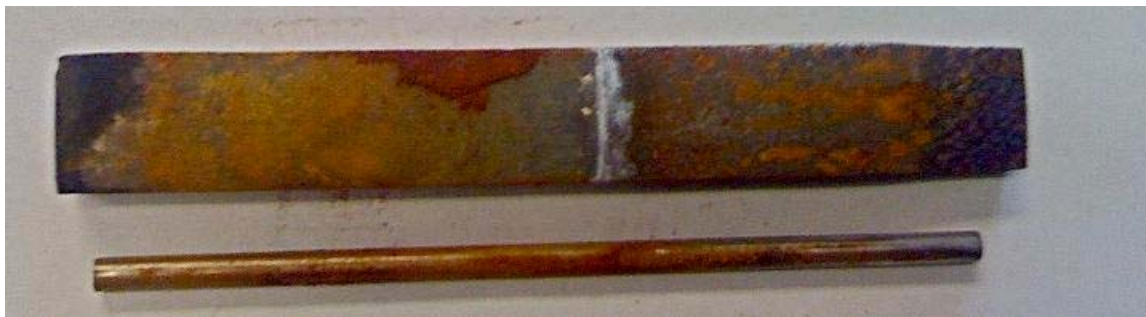
Figure 15. Natural seawater sample after 25 days in custom salt-spray test
